Site 8 – Tilton Property

Site 9 Railroad Swing Bridge

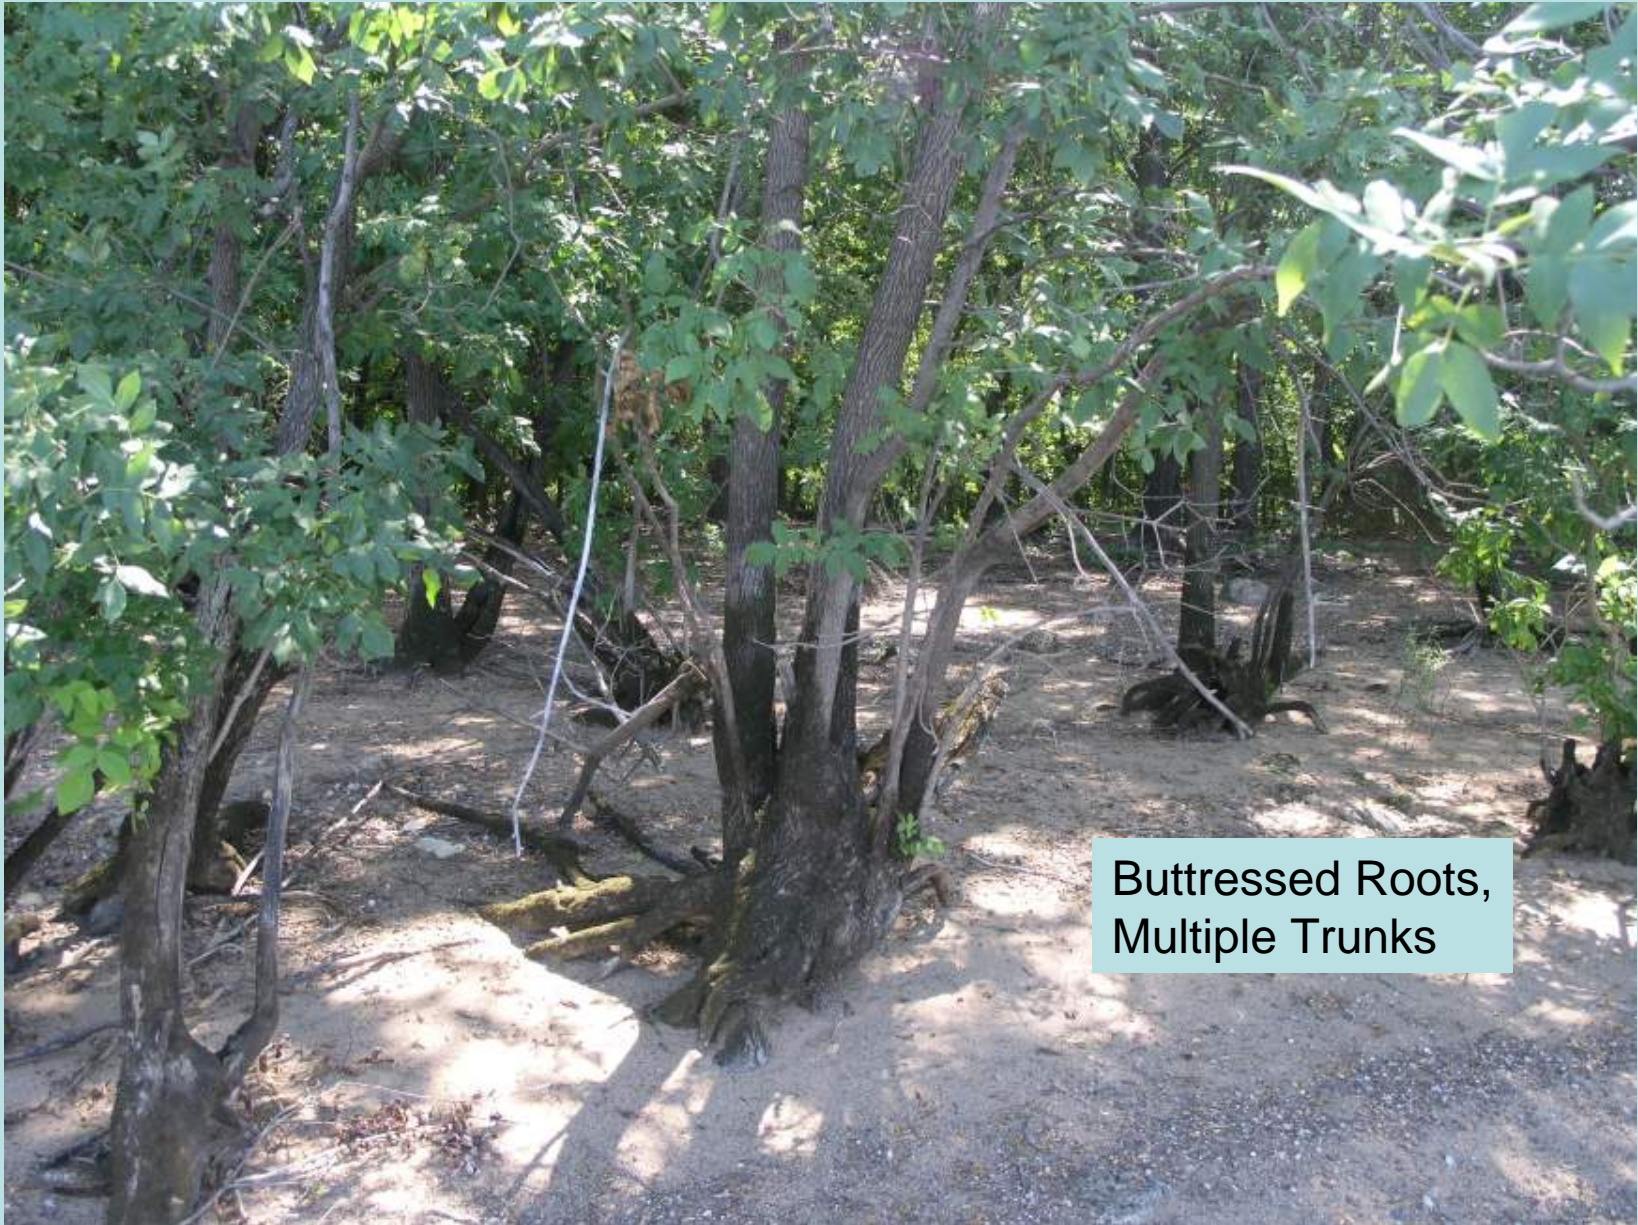
Buttressed Roots,
Multiple Trunks

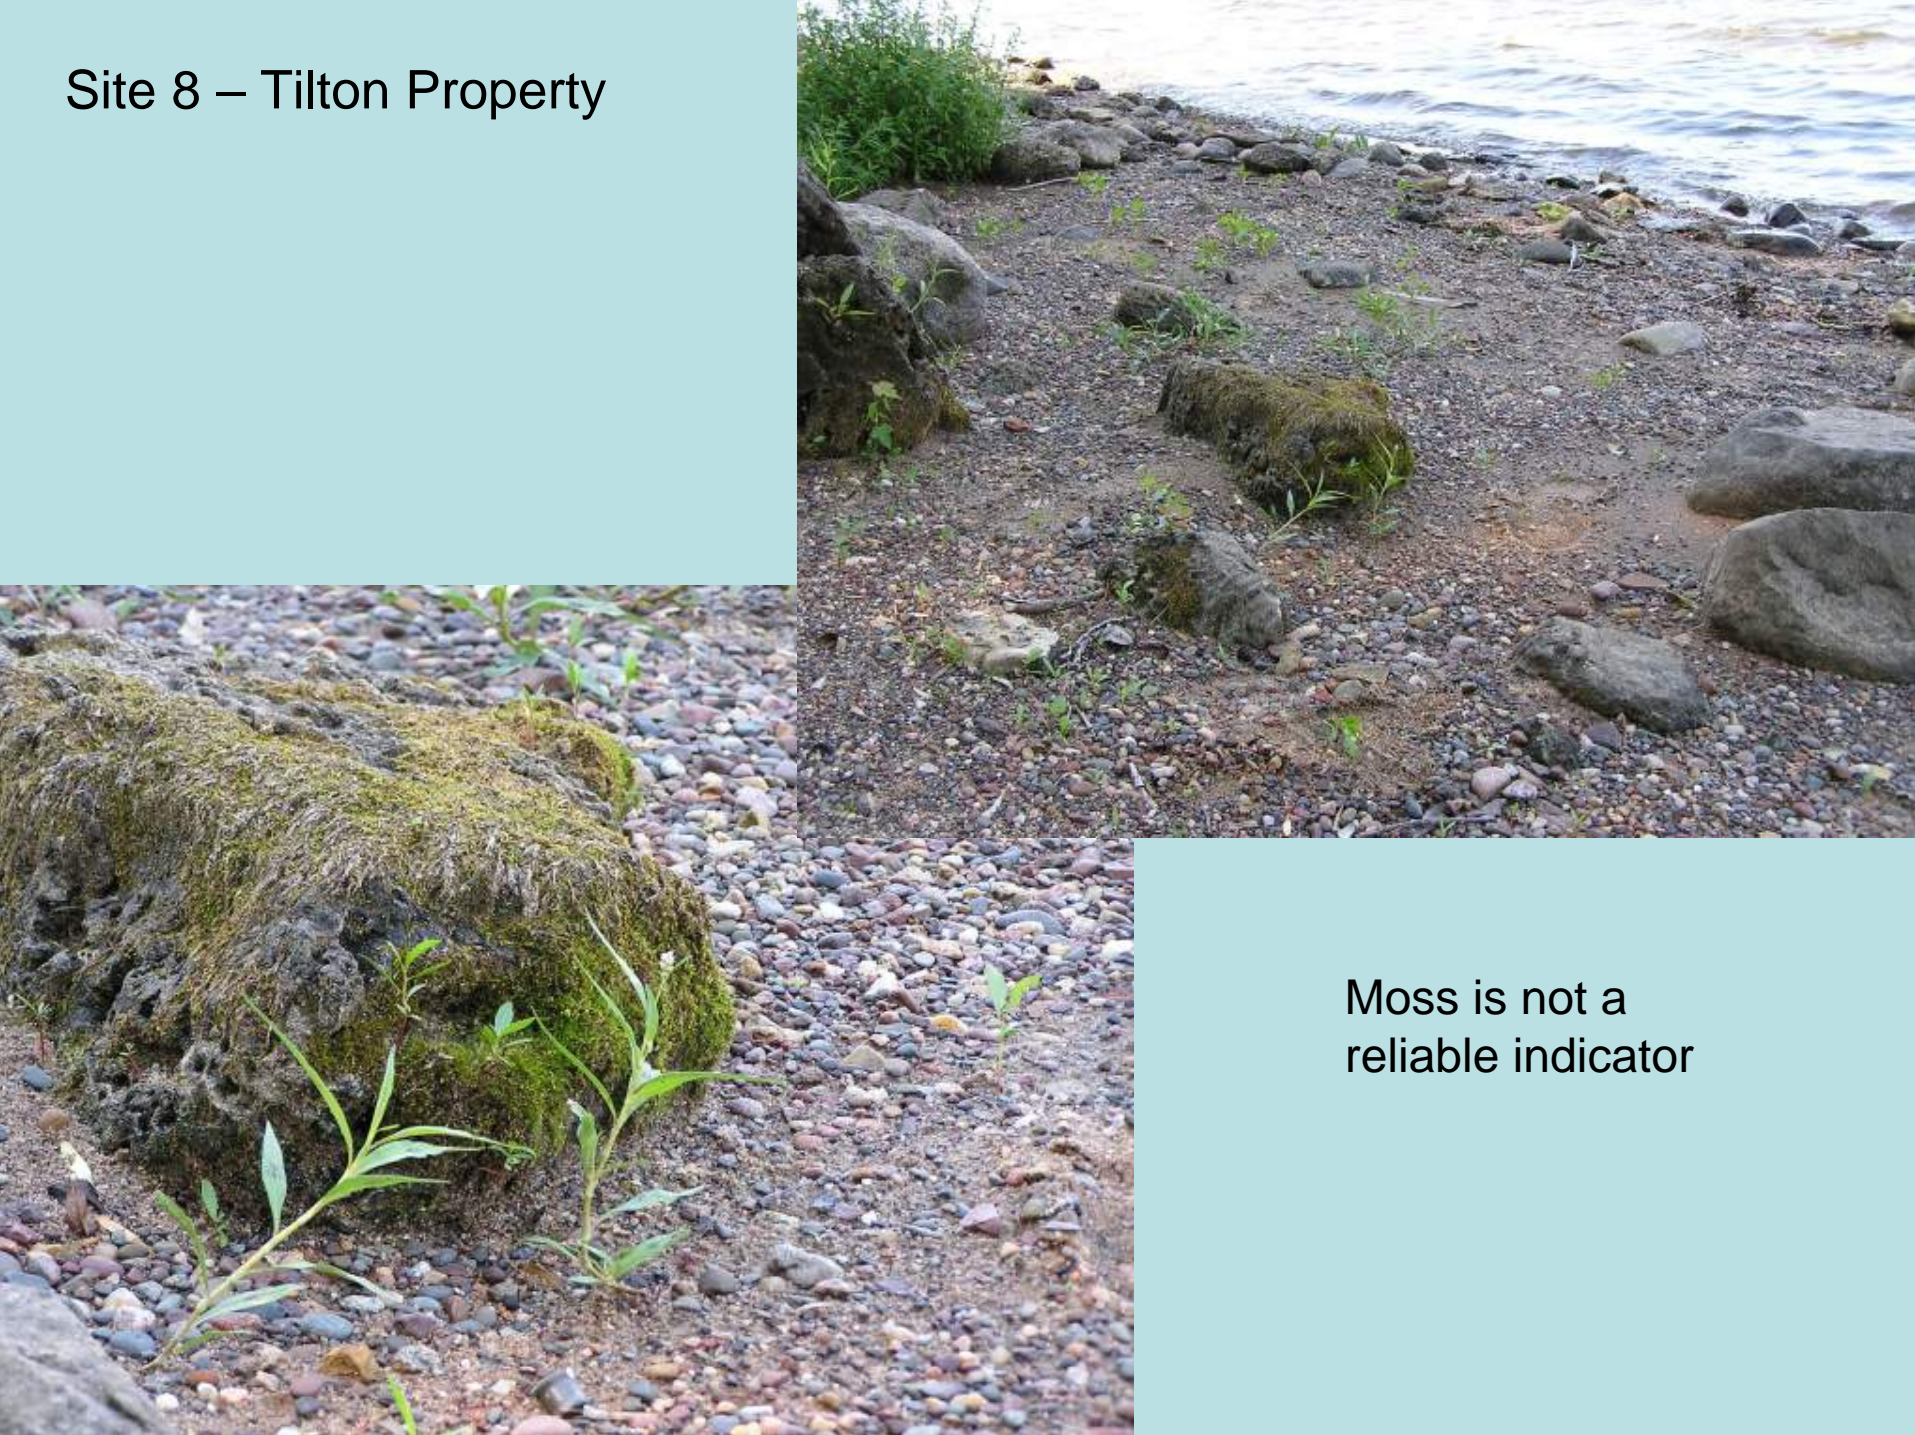
Moss is not a
reliable indicator

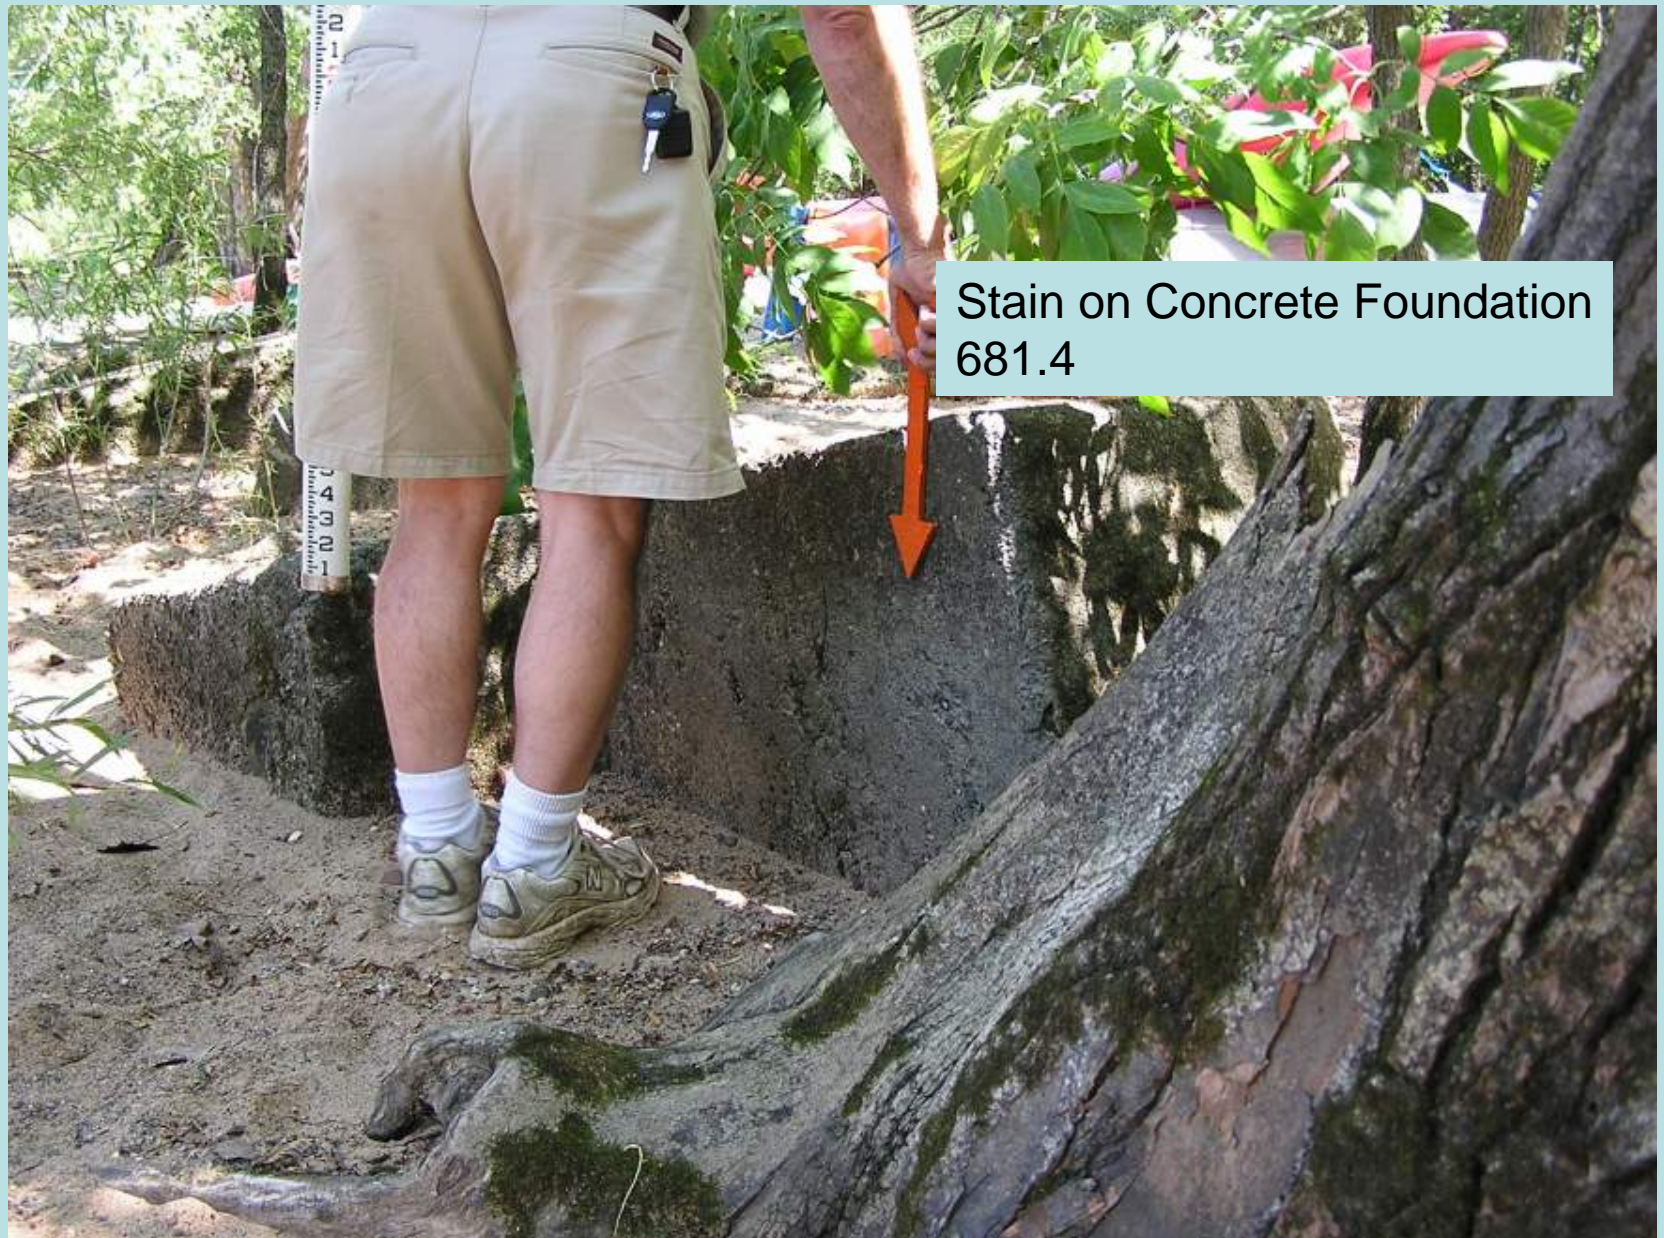
Stain on Concrete Foundation
681.4

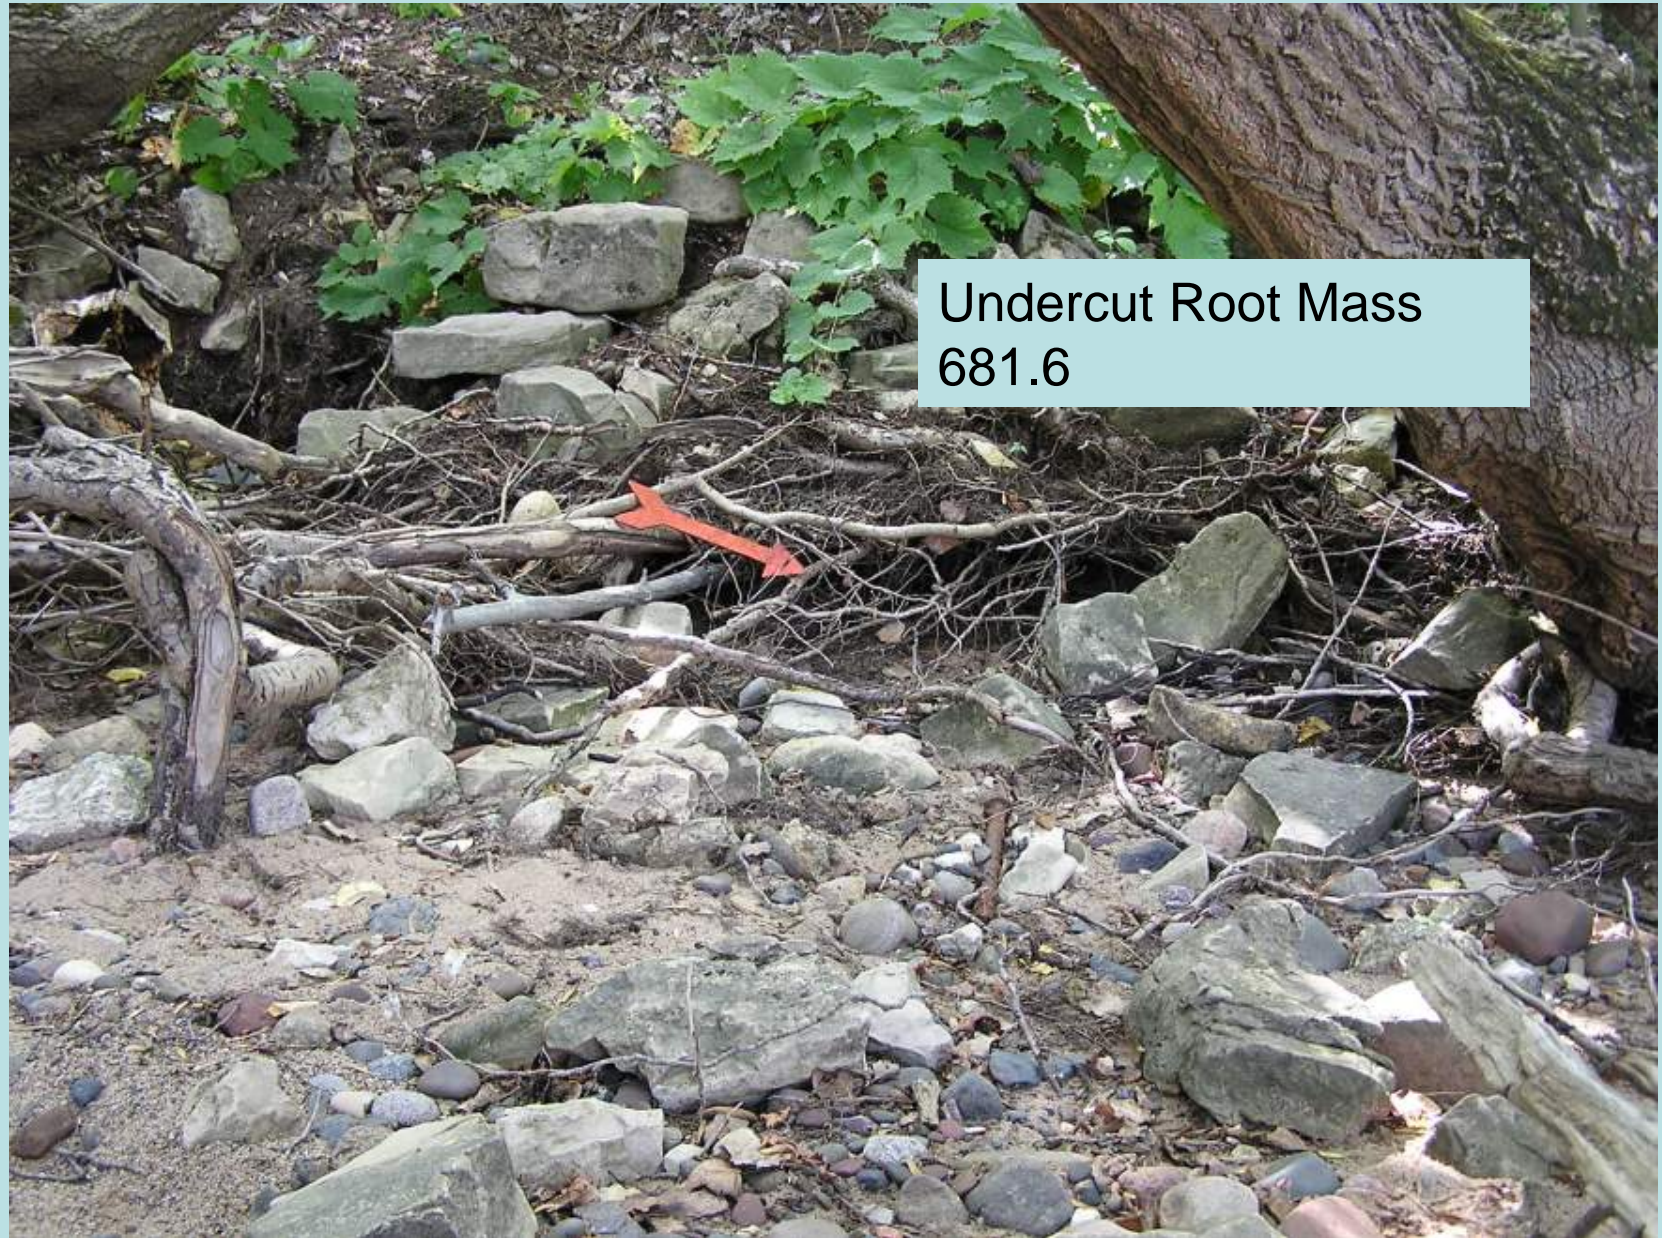
Undercut Root Mass
681.6

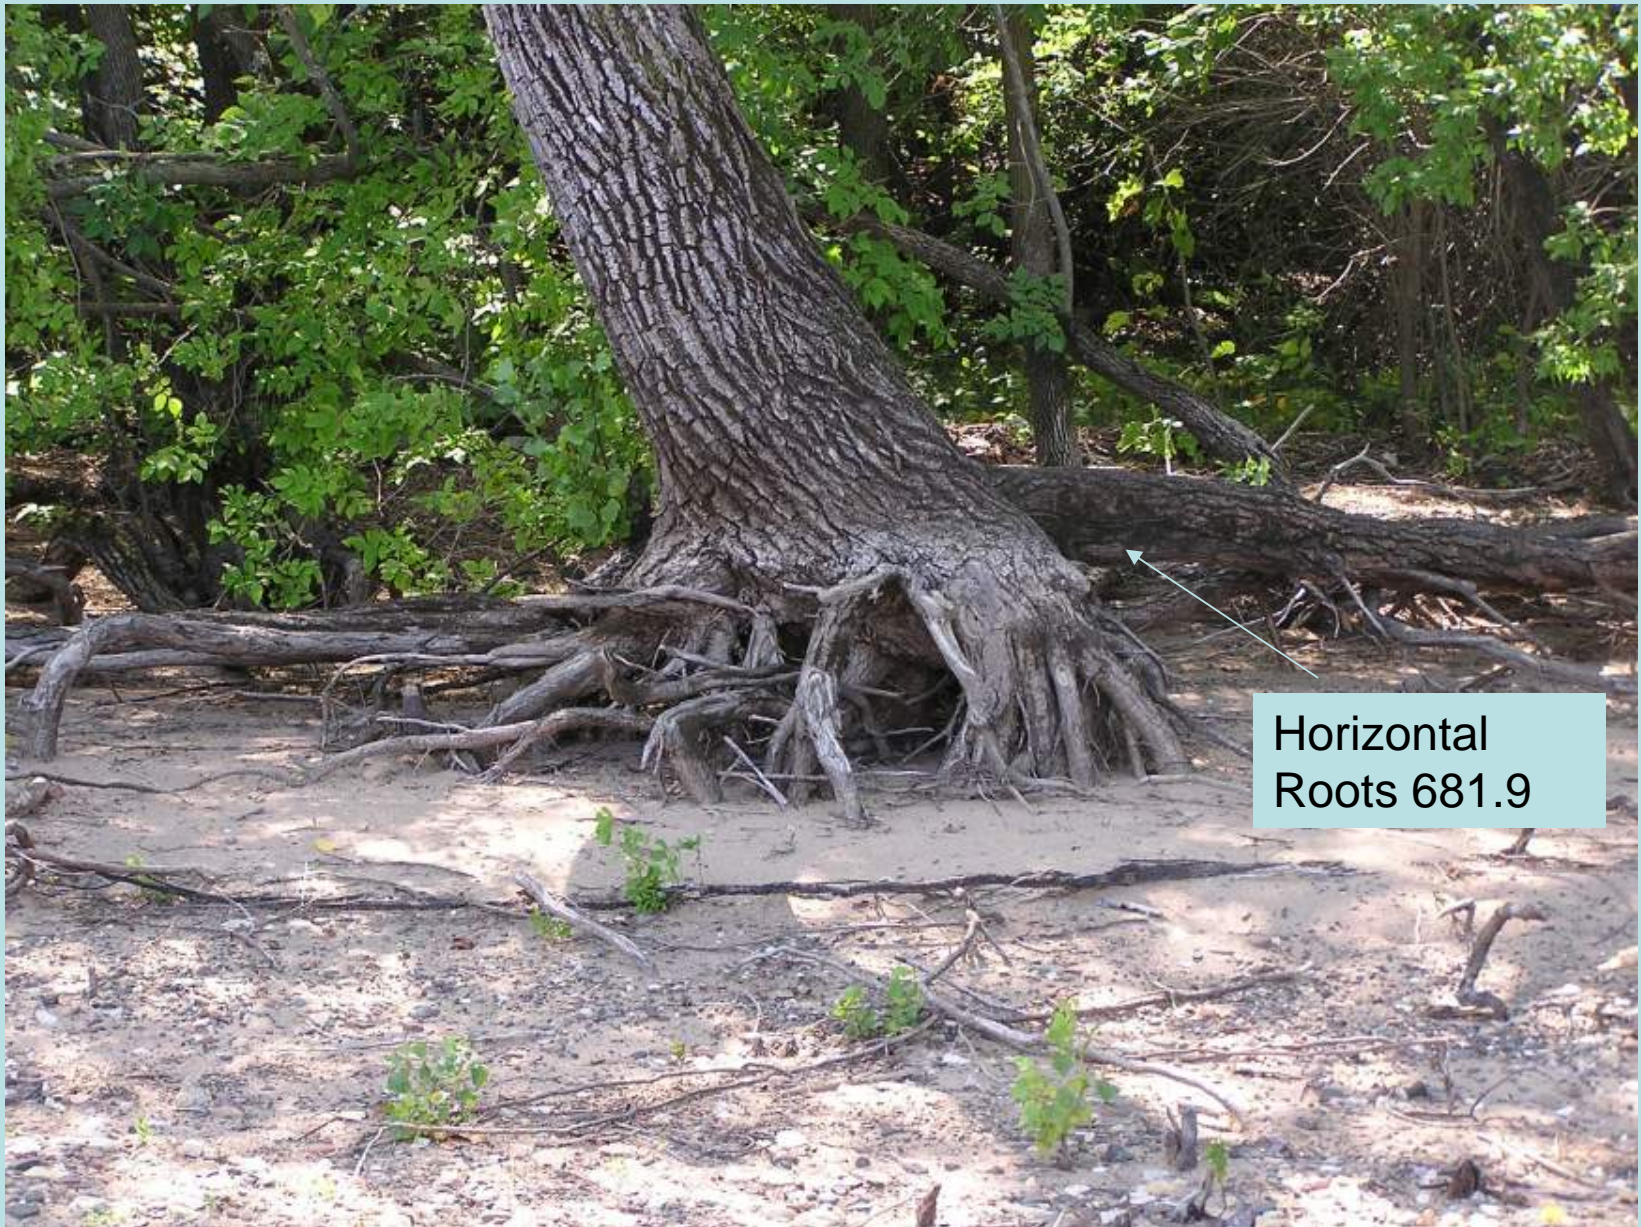
Horizontal
Roots 681.9

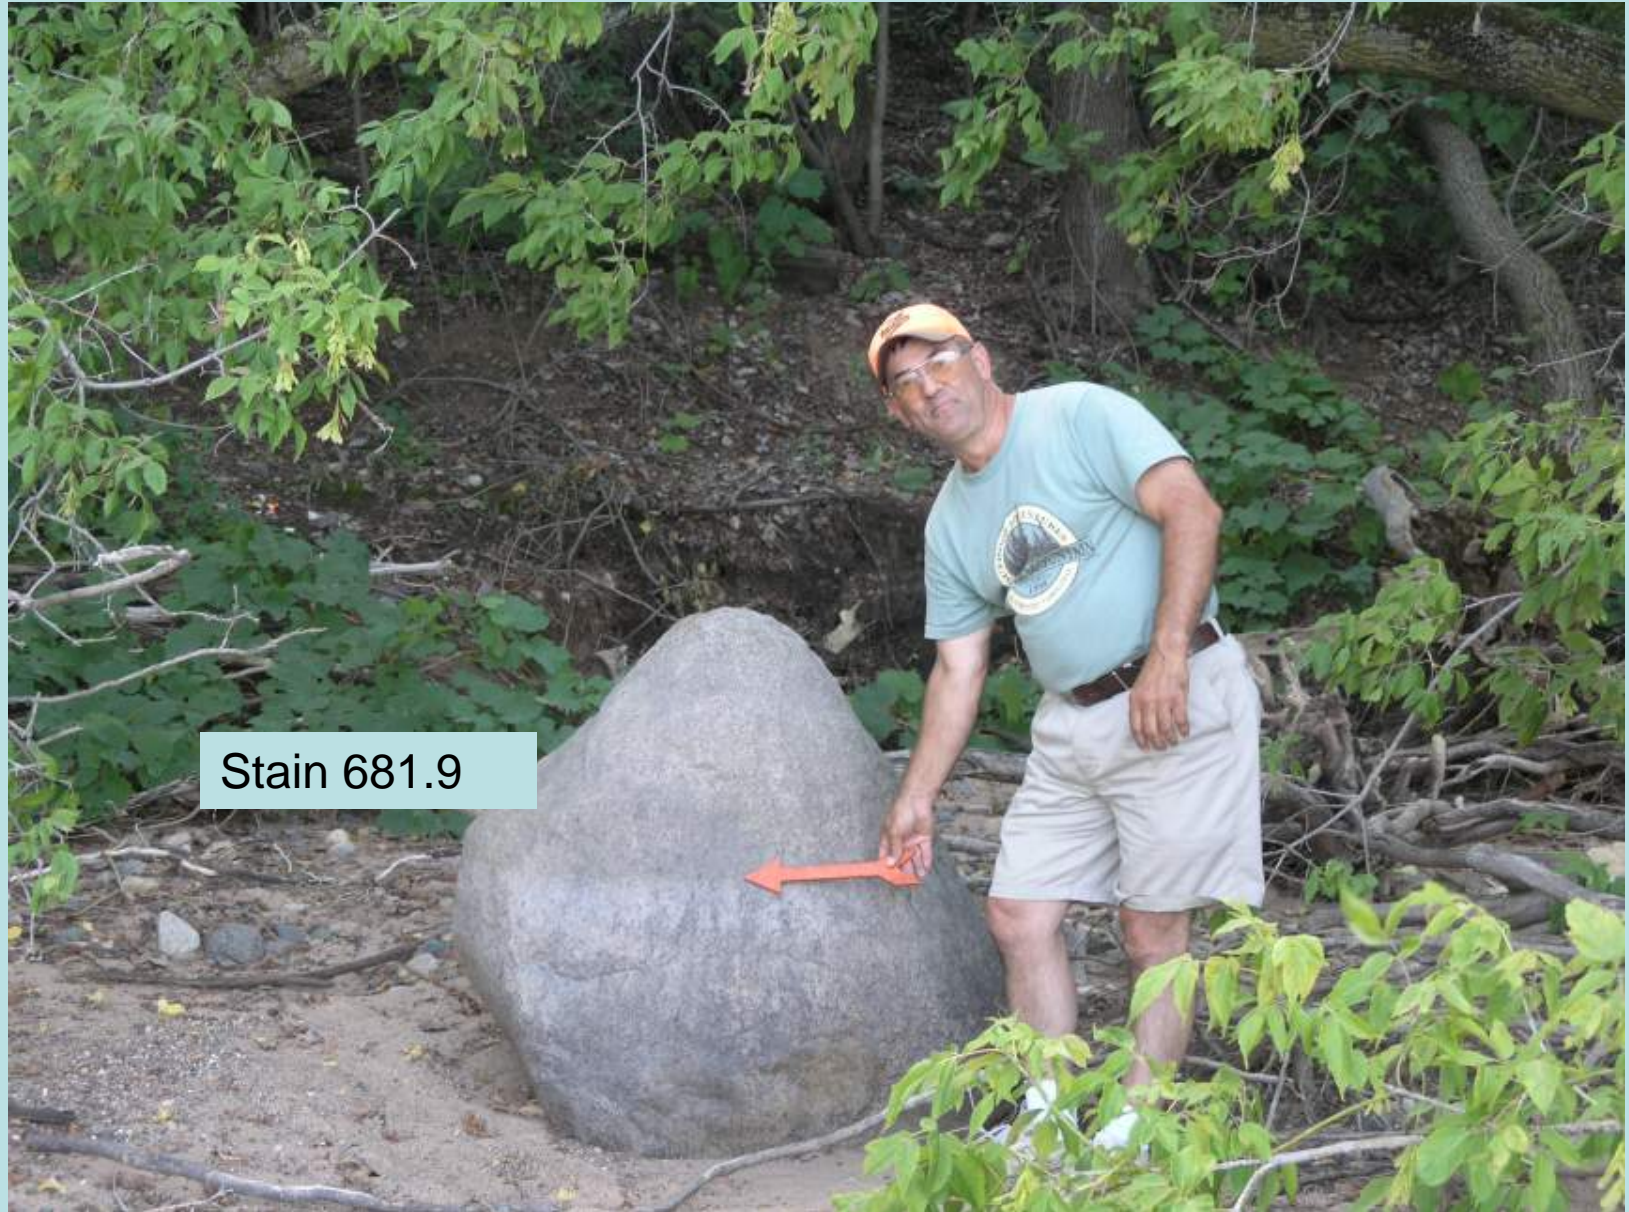
Stain 681.9

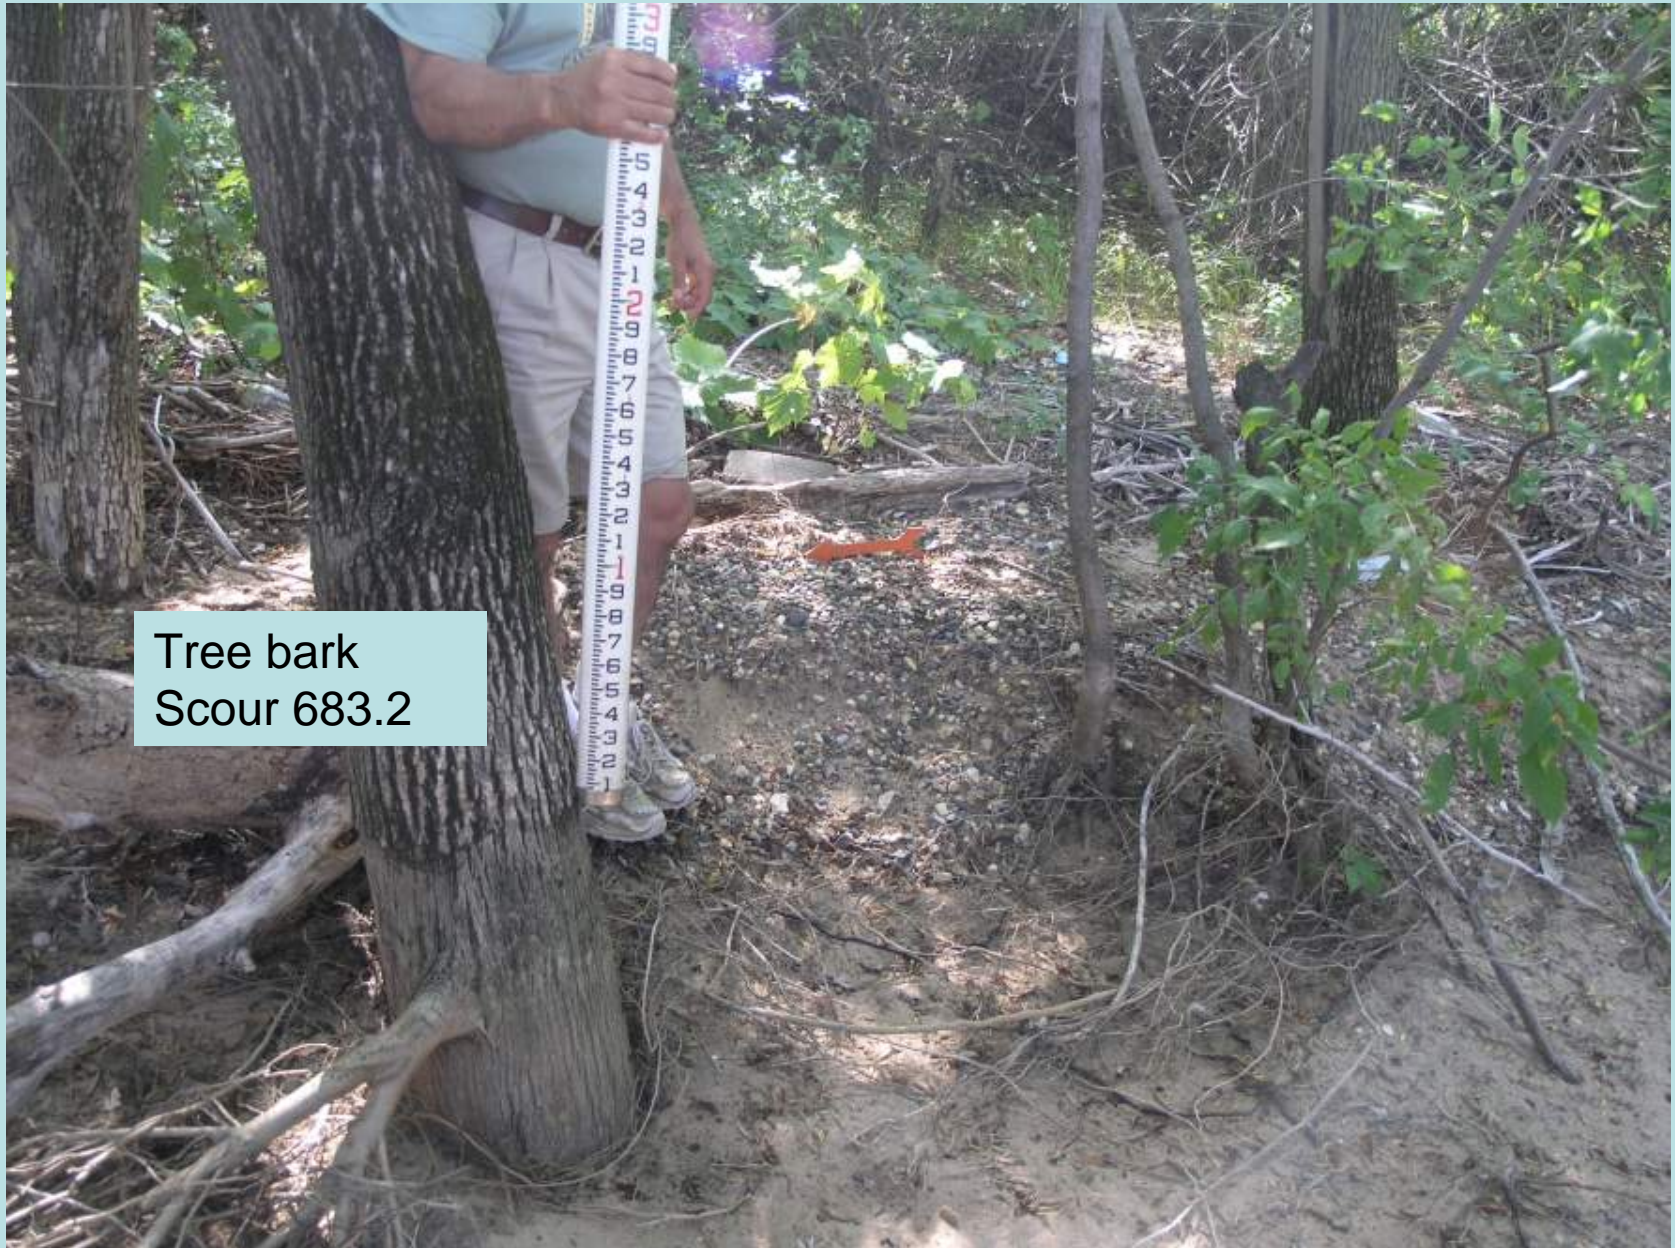
Tree bark
Scour 683.2
